Efficient and Effective Vapor Intrusion Mitigation Techniques

Presented by: Thomas E. Hatton
CEO – Project Director

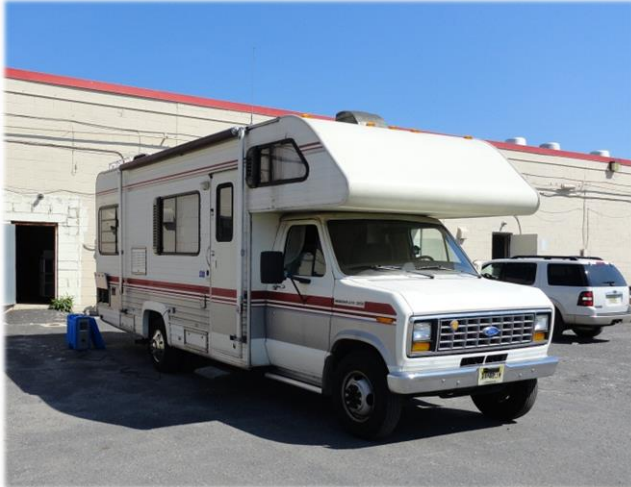
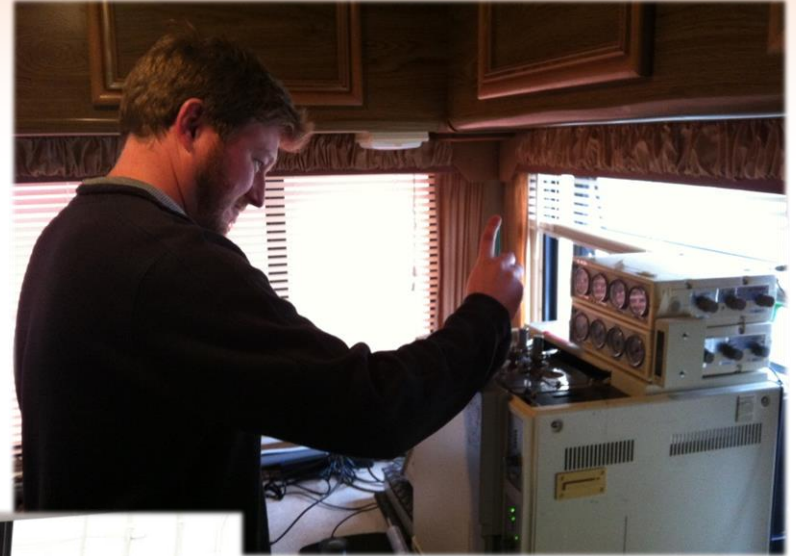
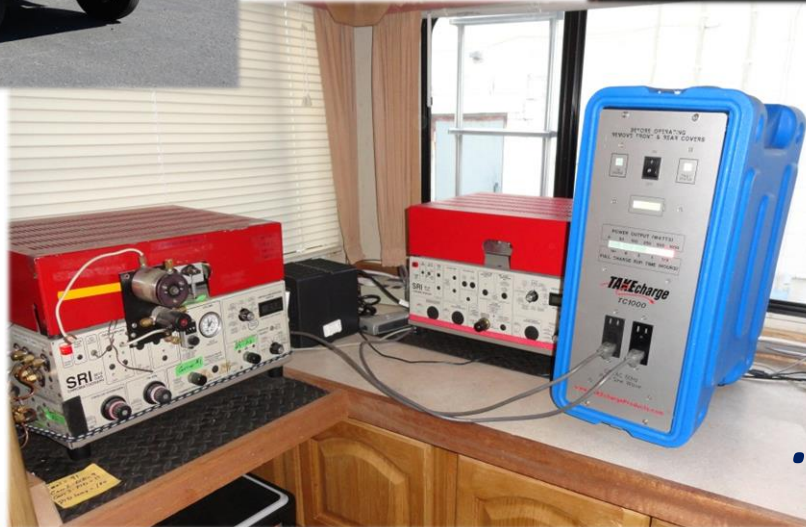
Plume delineation...

... Using a mobile lab

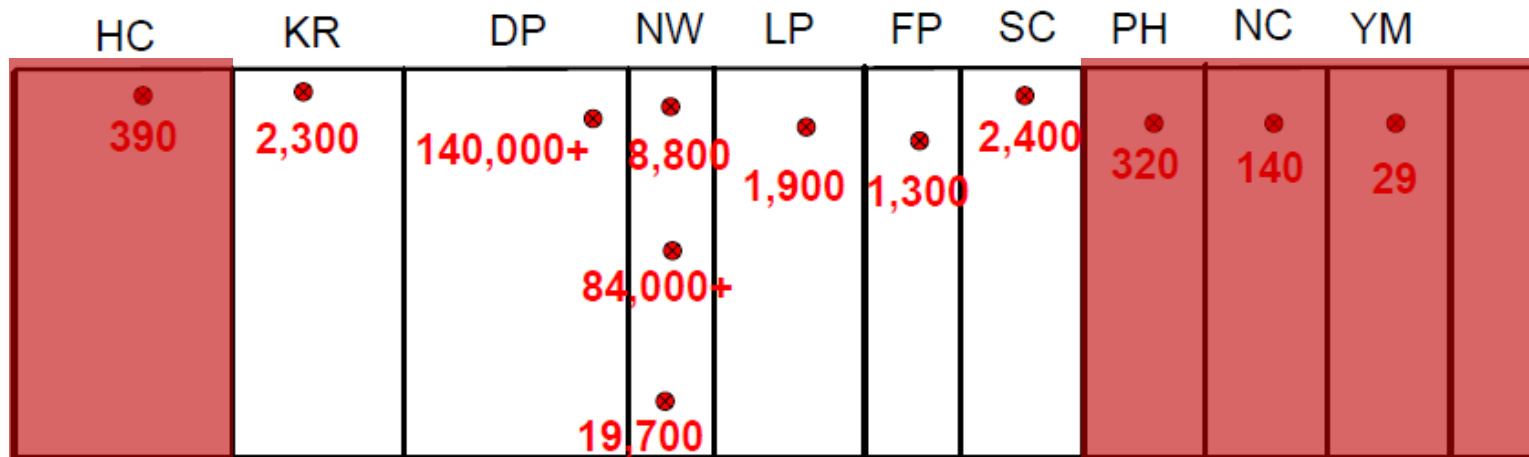
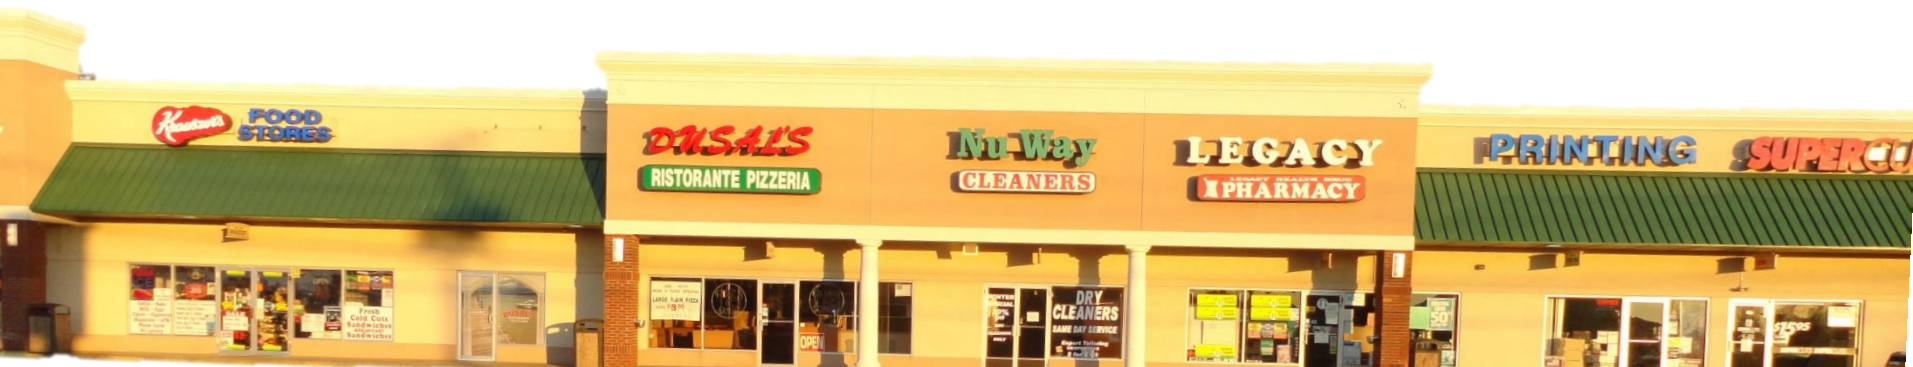
Plume Delineation

For Strip Malls...

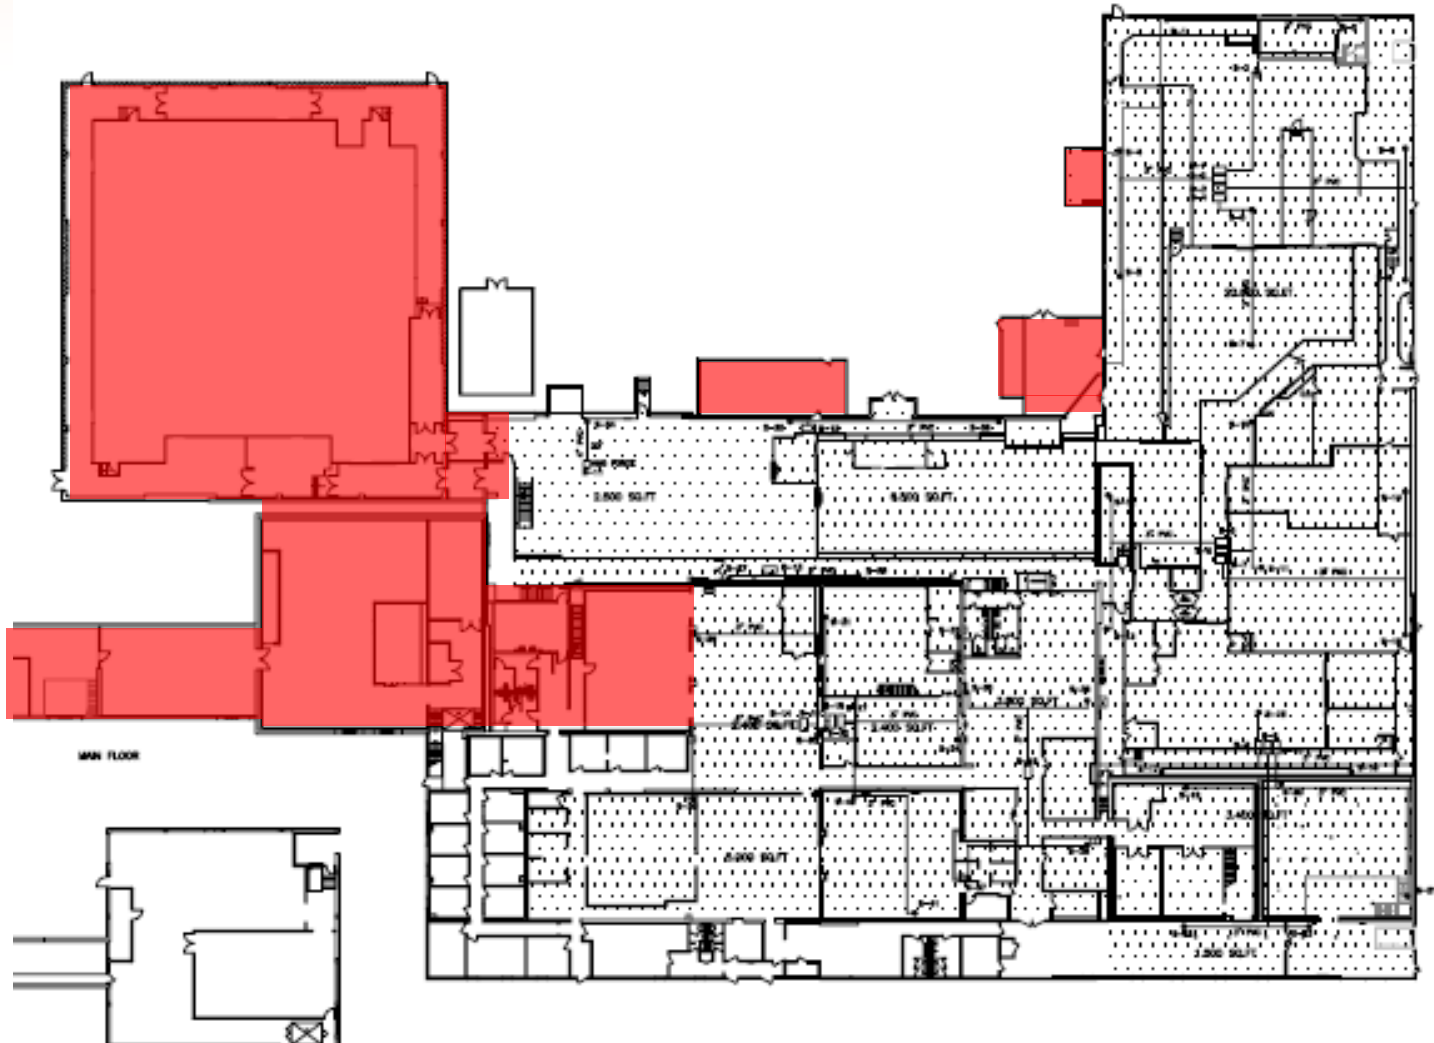
Plume Delineation

For Industrial Buildings...

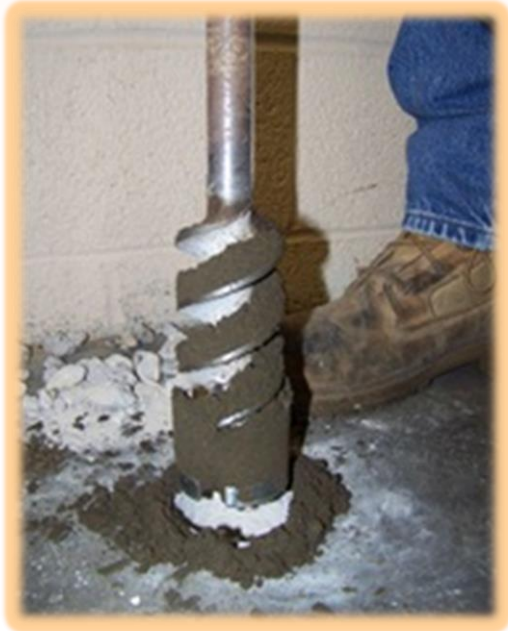
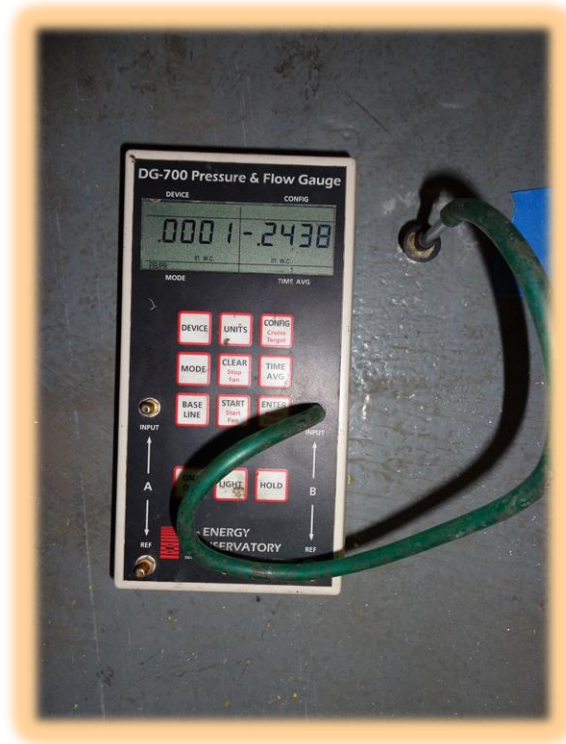
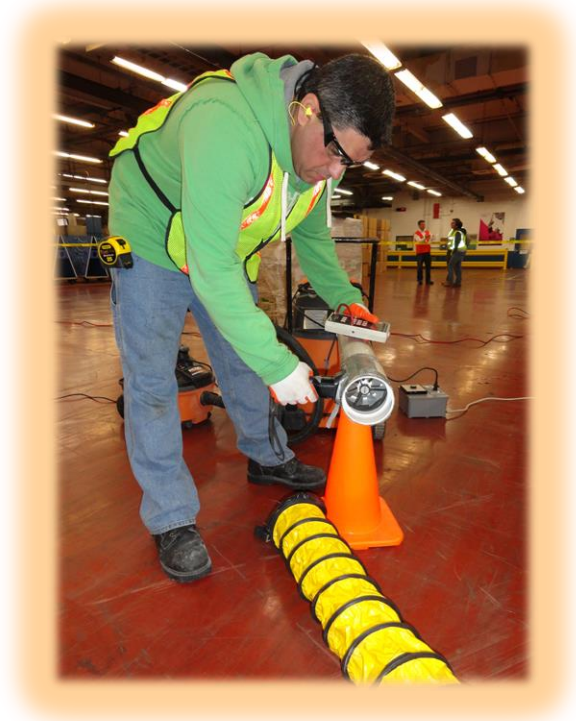
Using precision diagnostics to map permeability...

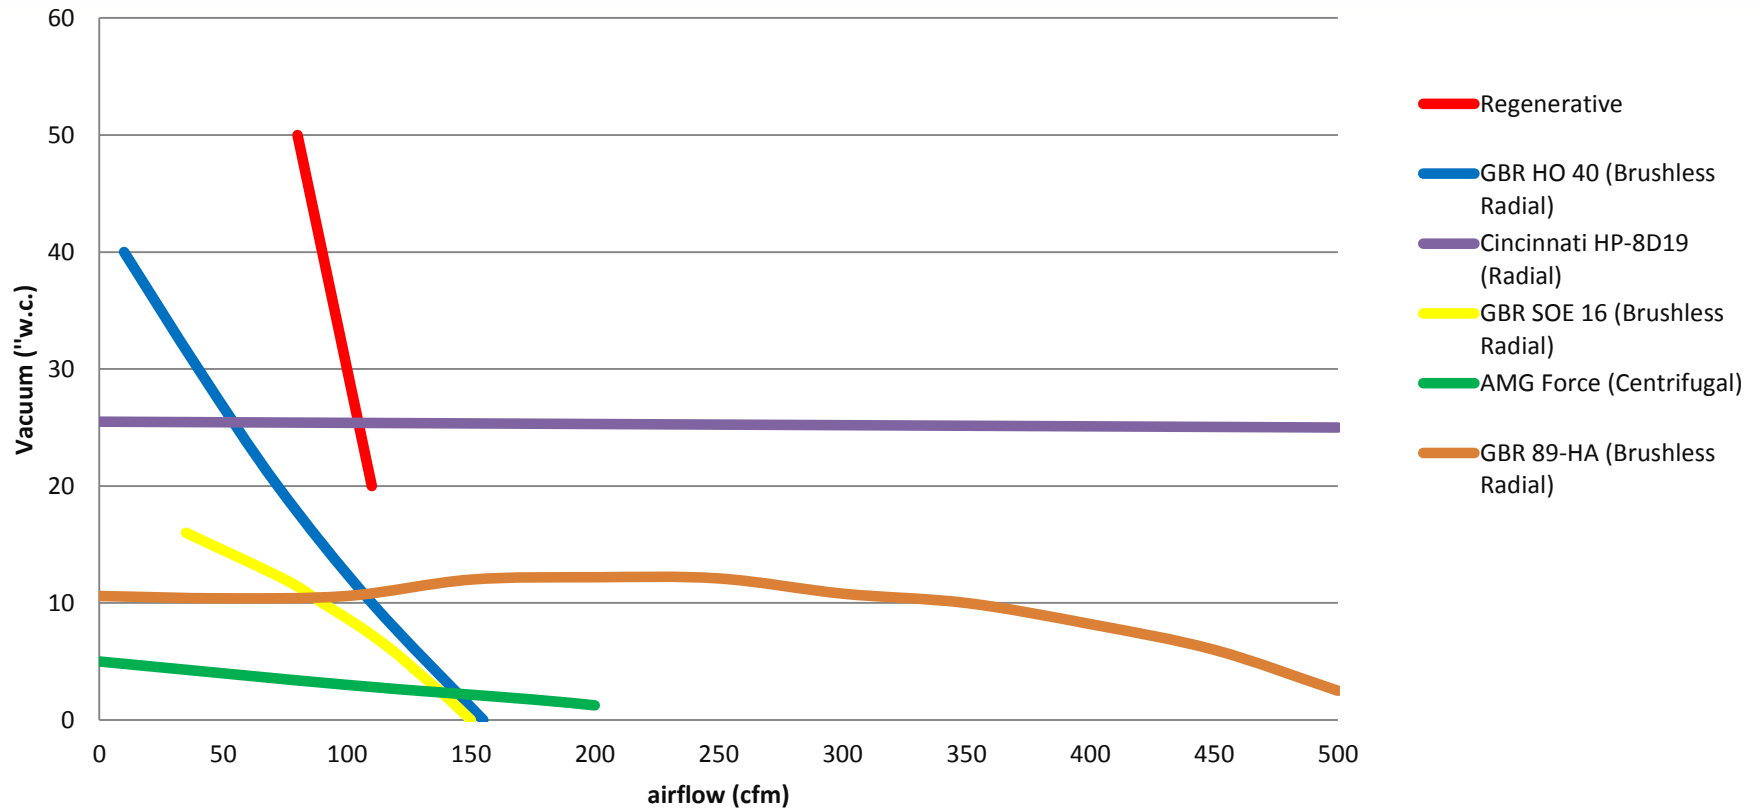
Blower Sizing

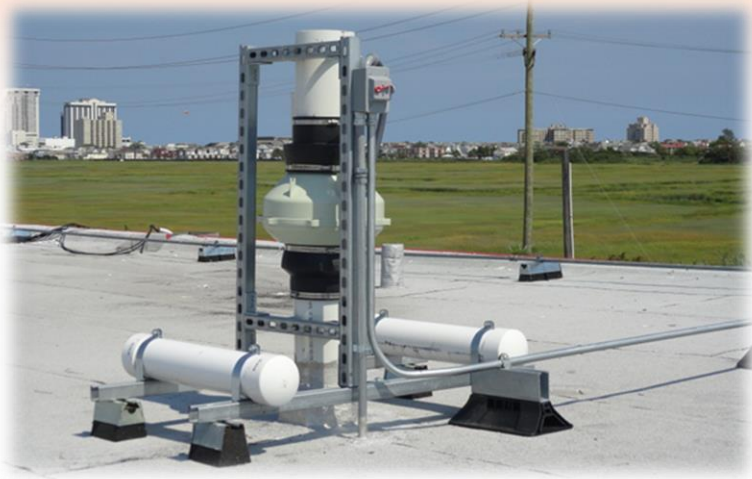
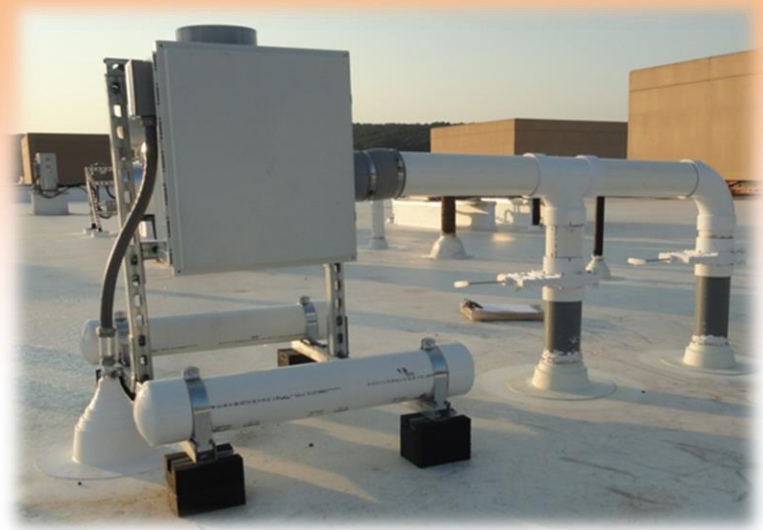
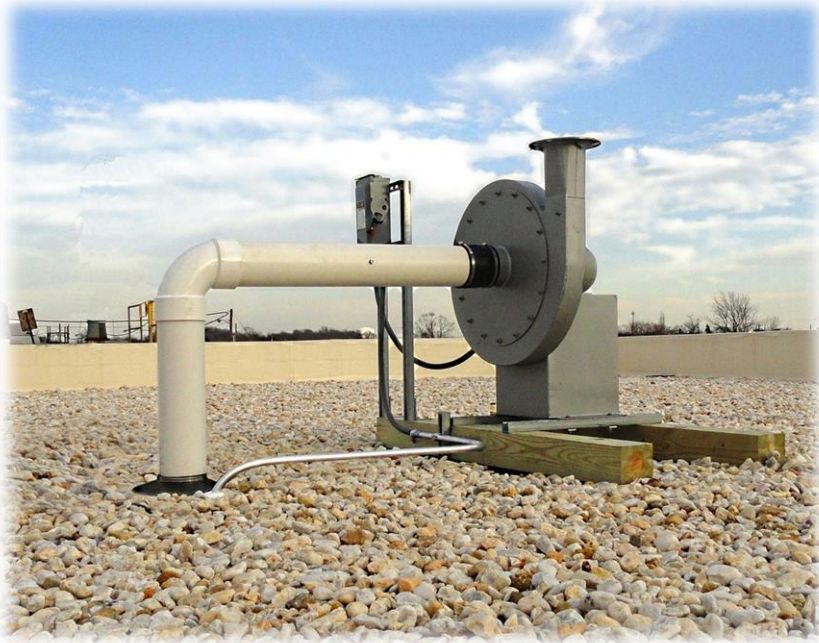
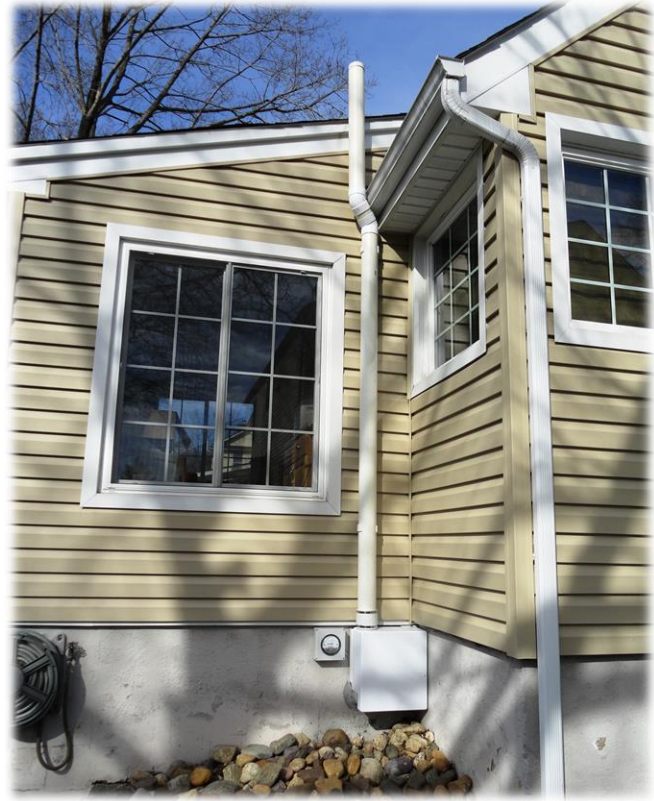
Blower Types

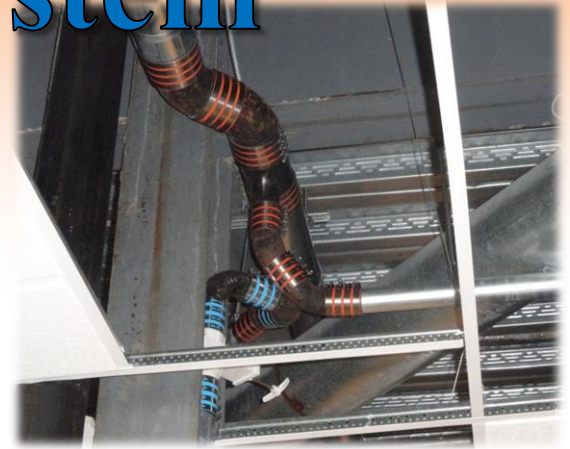
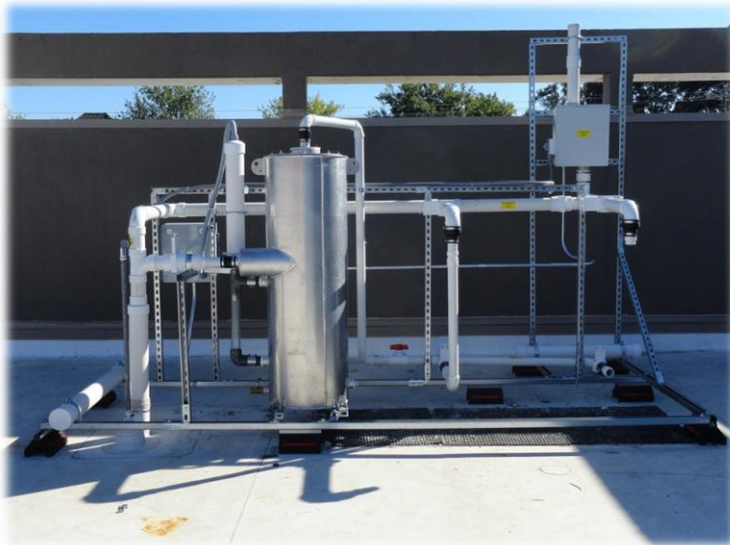
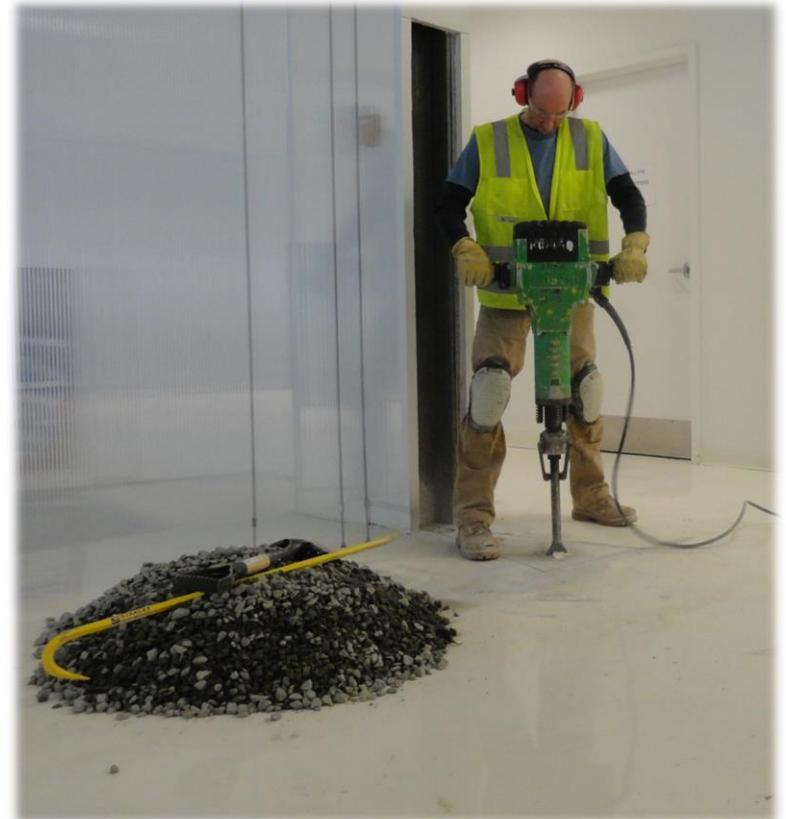
Step 3 : Installing a System

- Use existing building features
- Hide system components
- Check pipe pitches
- Suction pit clean out
- Check building use groups

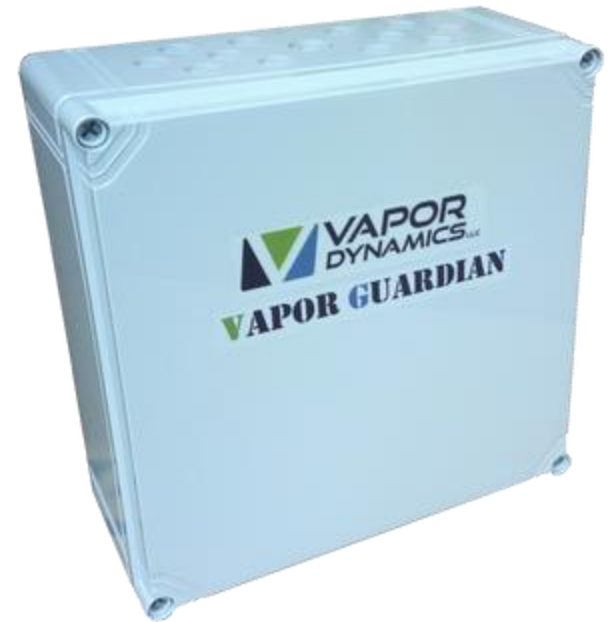
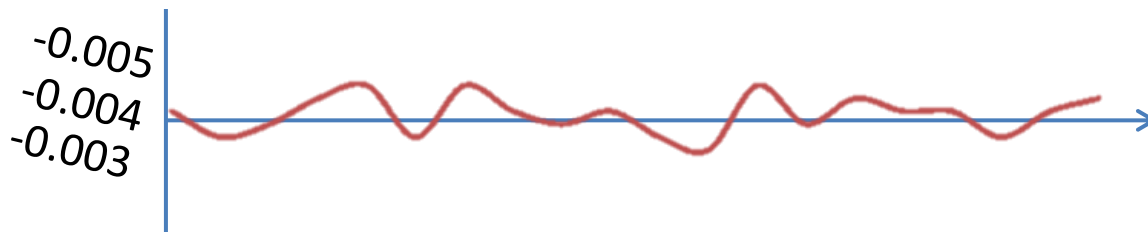
Vapor Guardian 5500

- Dynamically control 10 blower systems
- Control of sub slab vacuum
- Assign functional priority
- Monitor up to 55 inputs
- Fault notifications
- Automated reporting

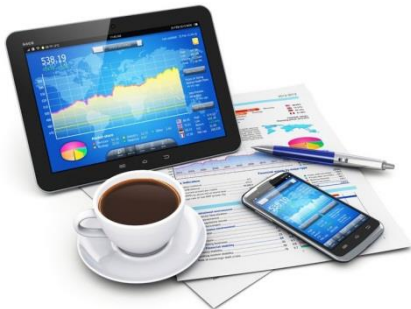
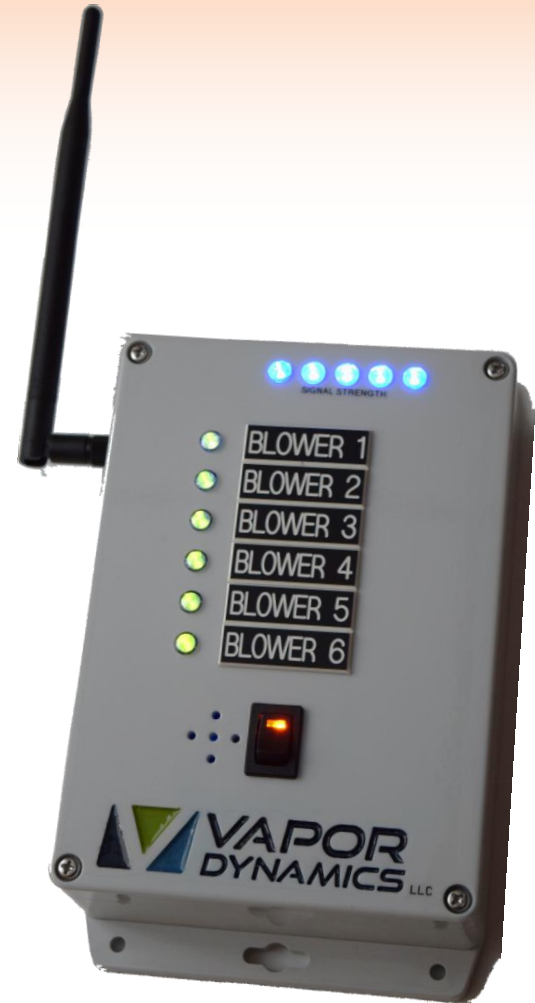
Vapor Guardian 600

- Monitor up to 6 inputs
- Ideal for:
 - Individual residences
 - Multi-family housing
 - Small buildings
- Mobile fault notifications
- Automated reporting

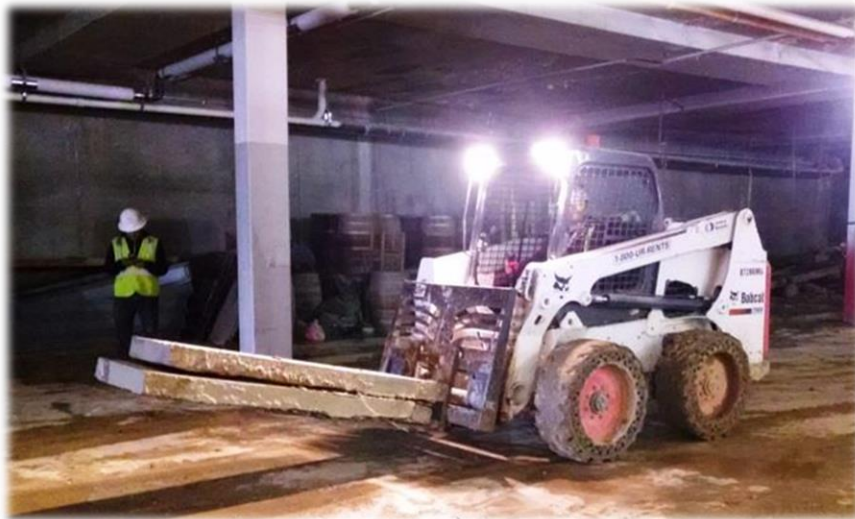
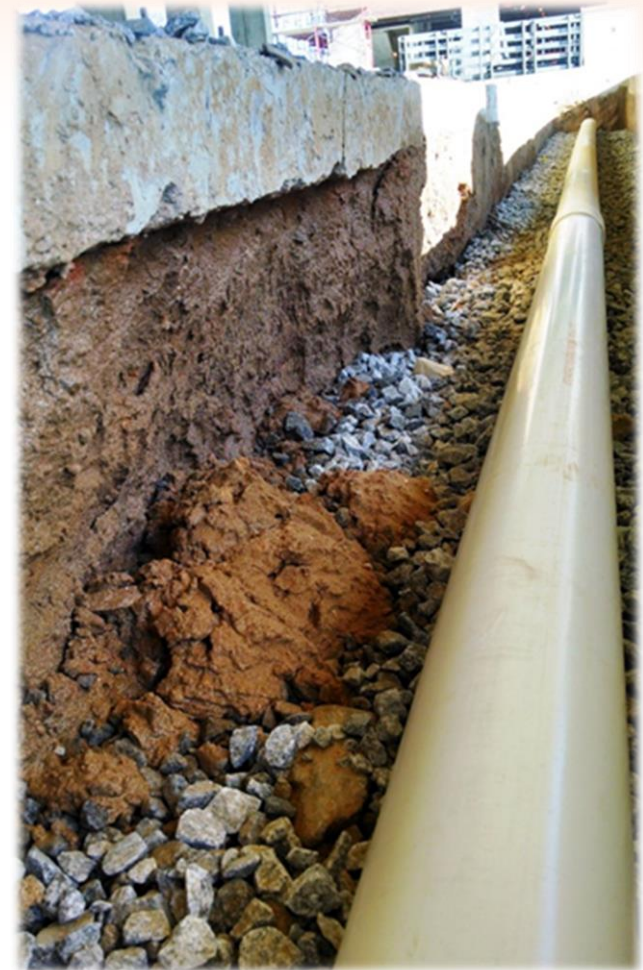
Case Study – The Details

- 2,100 sq. ft. trenching
- 19 vertical suction points
- 1 activated carbon unit
- 6 radial blowers

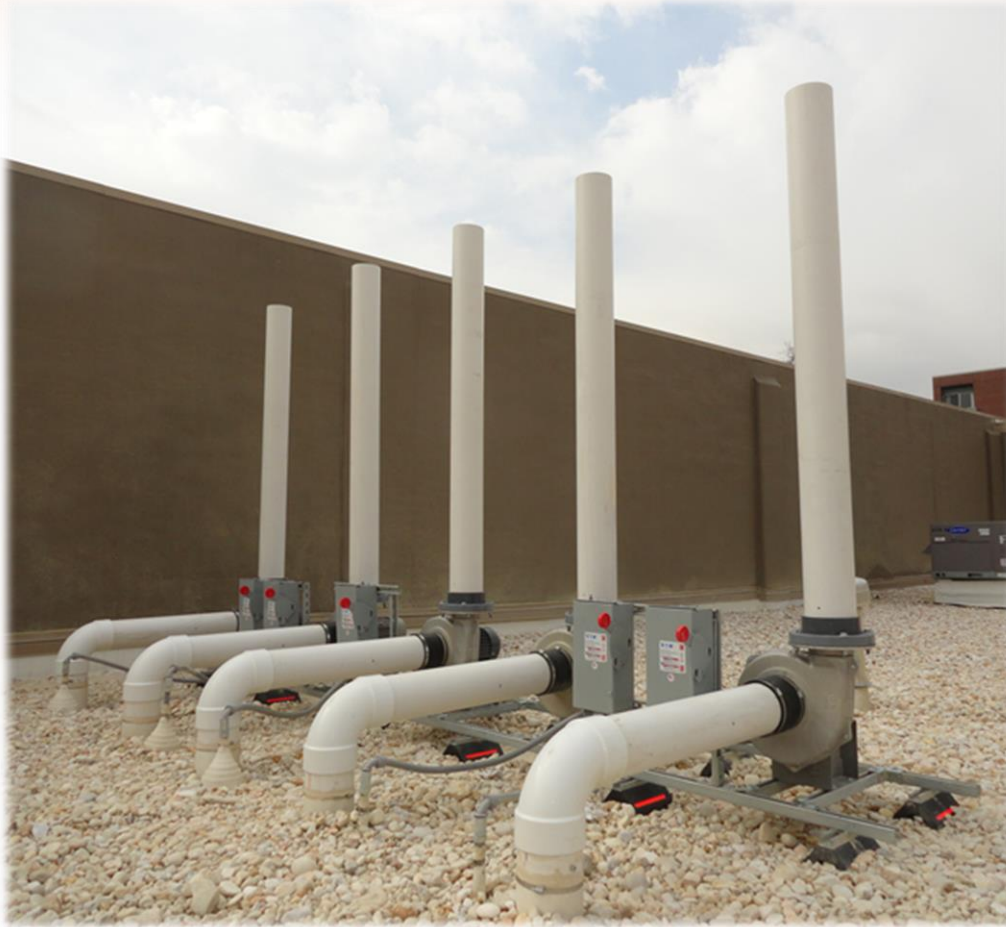
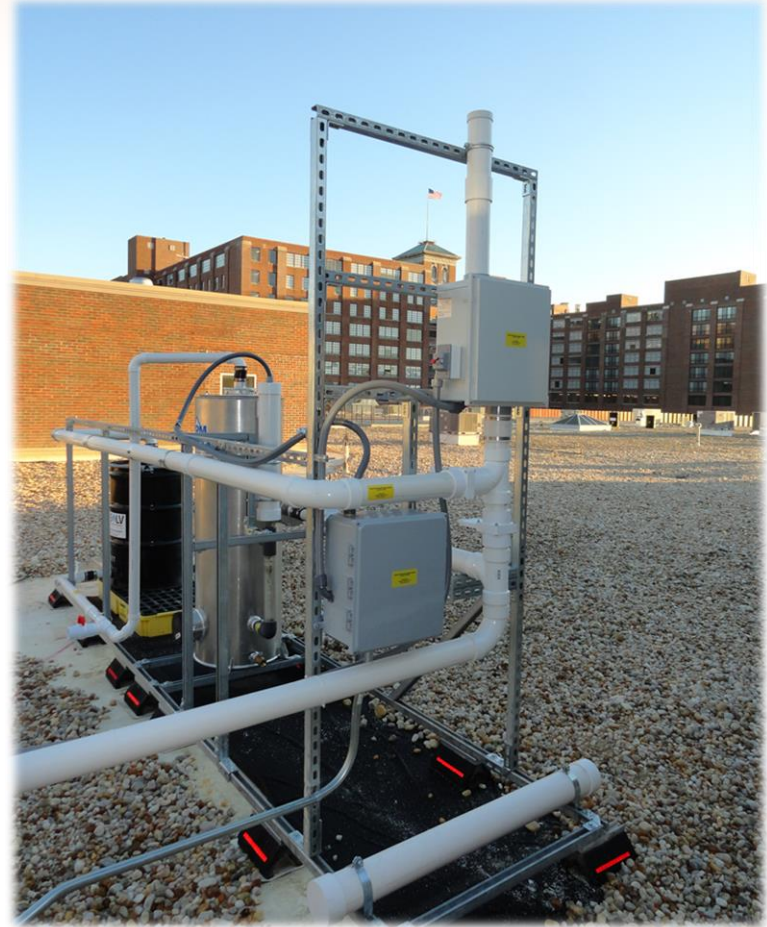
Case Study – The Photos

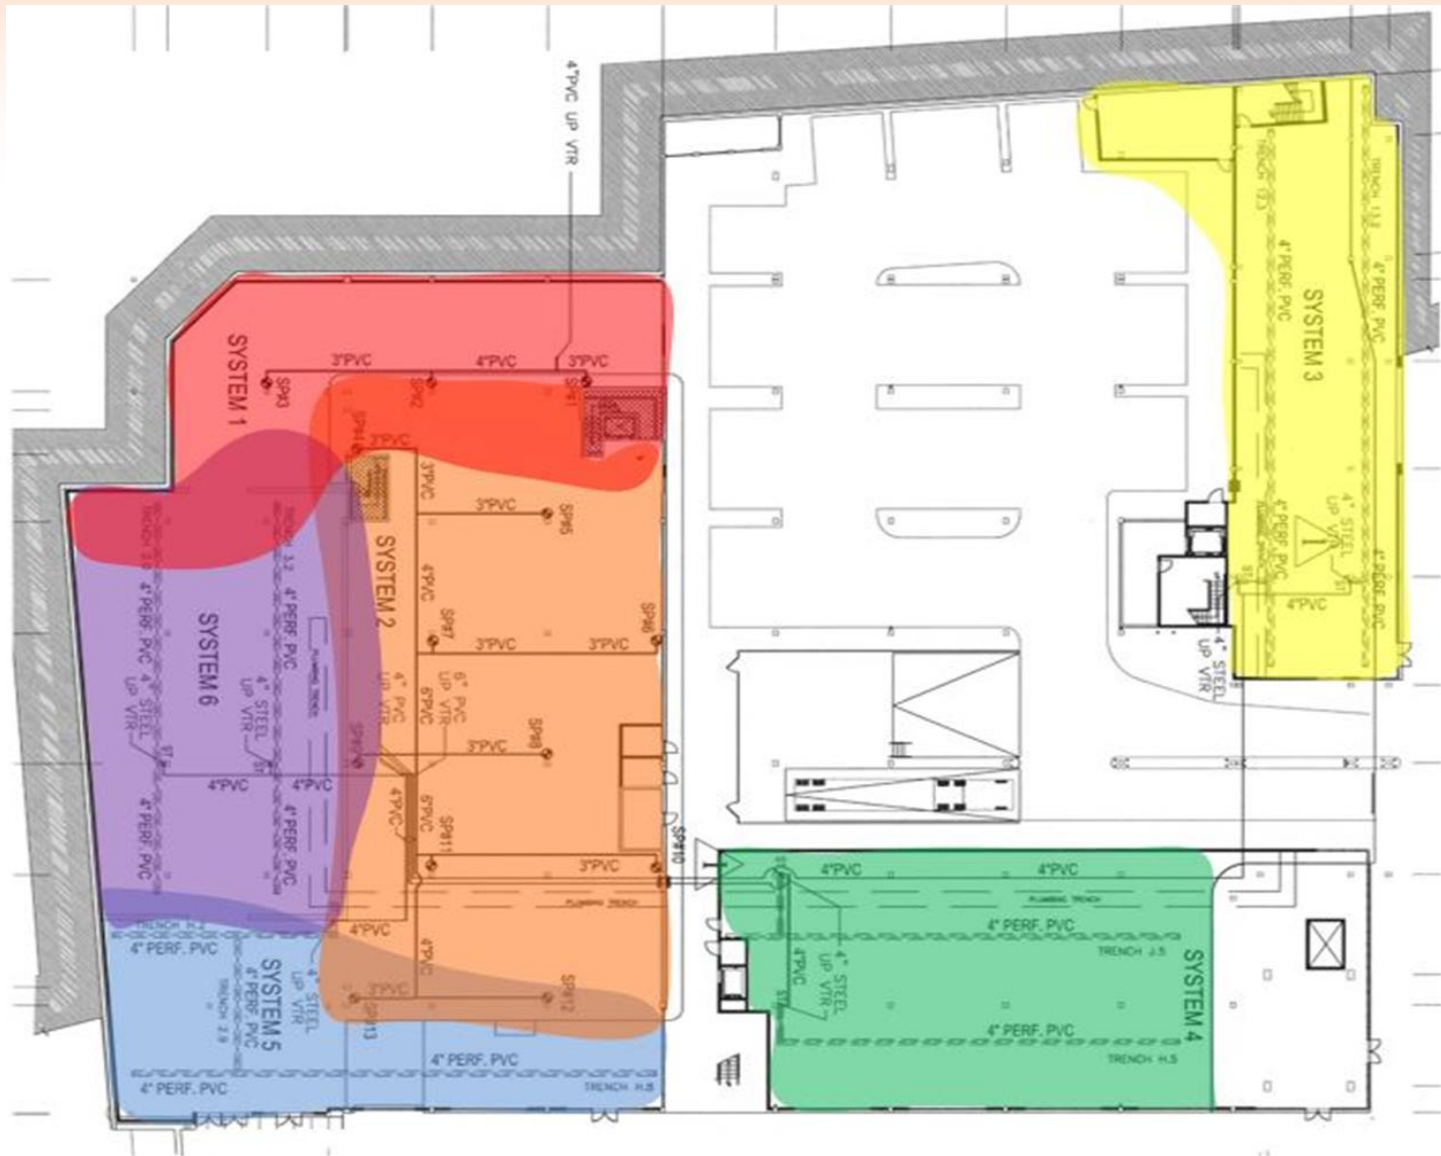
Case Study – The Results

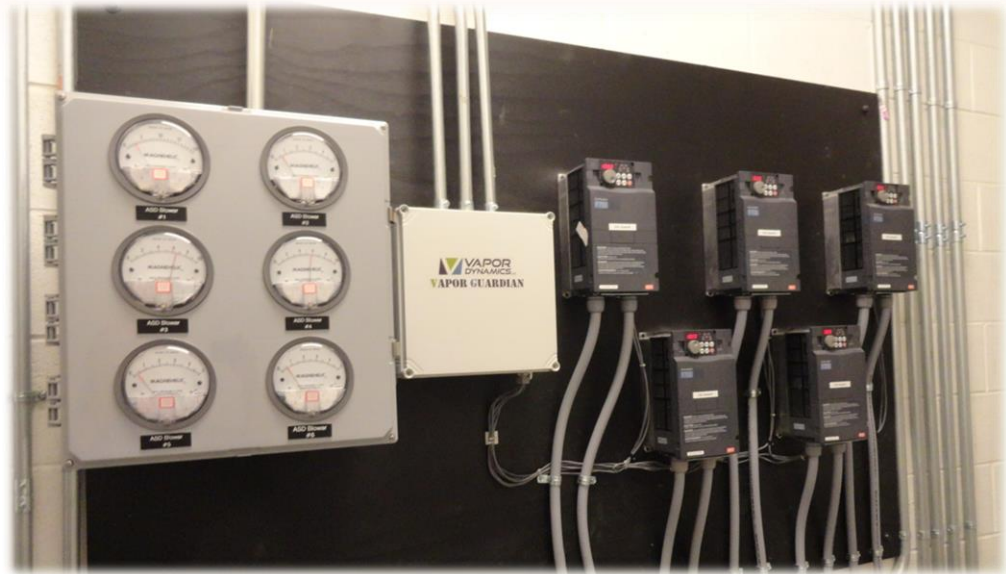
Case Study – The Technology

- Vapor Guardian 5500
- Monitors
 - Sub slab vacuum
 - Riser vacuum
 - Power consumption
 - Water level in knock out tank

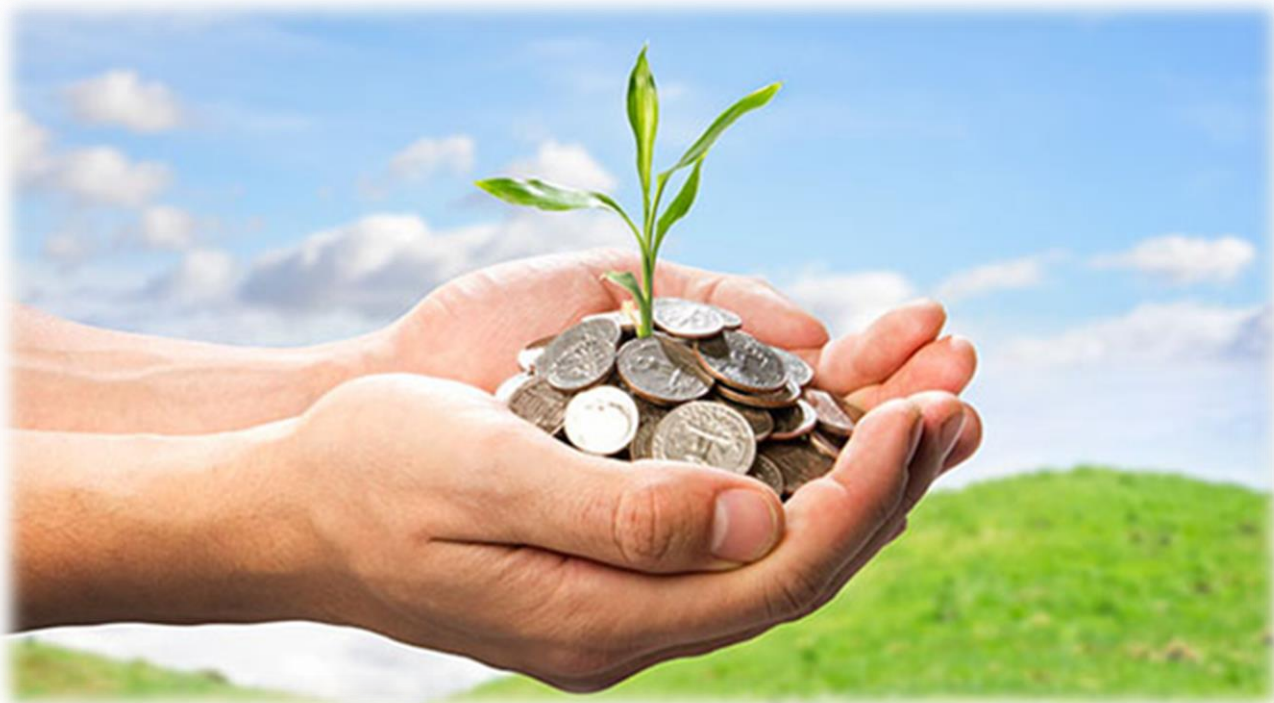
Case Study – The Savings

- \$3,300.00 in power consumption
- 18,000 Kwh
- 55,000 lbs. CO₂
